South Auckland Forgings Engineering Ltd
116 Waihoehoe Road, Drury 2113
P.O. Box 44, Drury 2247, Auckland, New Zealand
Tel: 64 9 2948437 Fax: 64 9 2948431
info@SafeGroup.co.nz
www.SafeGroup.co.nz

Procedure used to shorten steering shaft:

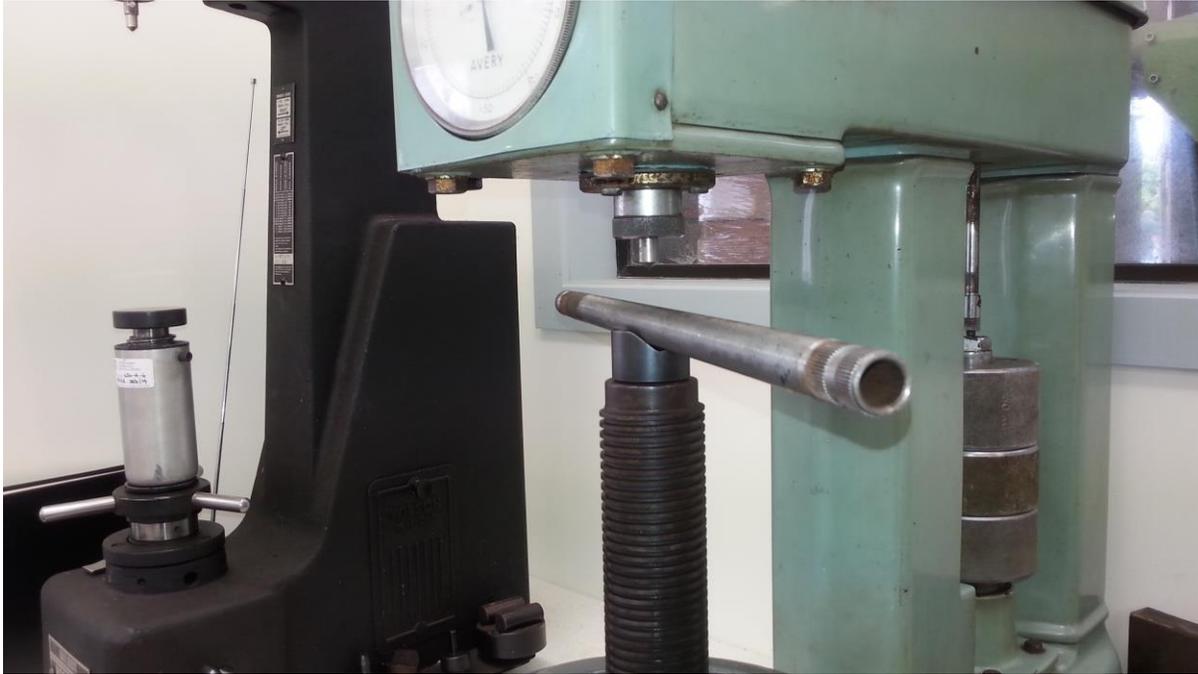
Hardness Test shaft to determine strength of material. Hardness measured at Rockwell B translates to indicated UTS of MPa

Hollow steering shaft hardness-tested at 85 Rockwell B, cross-referencing to an indicated Ultimate Tensile Strength (UTS) of 530 MPa. Shaft cross-sectional area of 139mm² indicates a tensile load-carrying capacity of approx 73kN (7.5 tons).

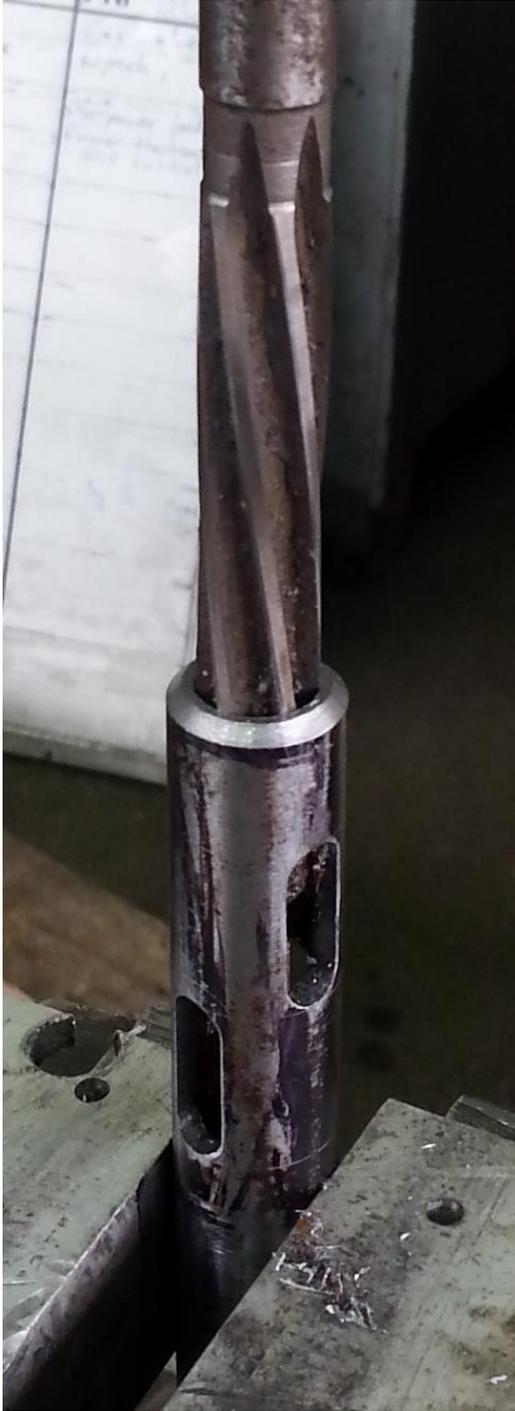
Ream Hole for Spigot

Cut faces of steering shaft tube were prepared for welding by machining a 2mm x 45degree chamfer on each. The center hole was reamed to ensure consistent sizing, and 4 longitudinal weld slots of 20mm long x 7mm wide were milled in each. Slots were placed opposite each other (180deg apart), with the 2nd two slots in each half of the shaft being 90deg rotated from 1st pair, which were in urn 15mm back from the butt-joint.

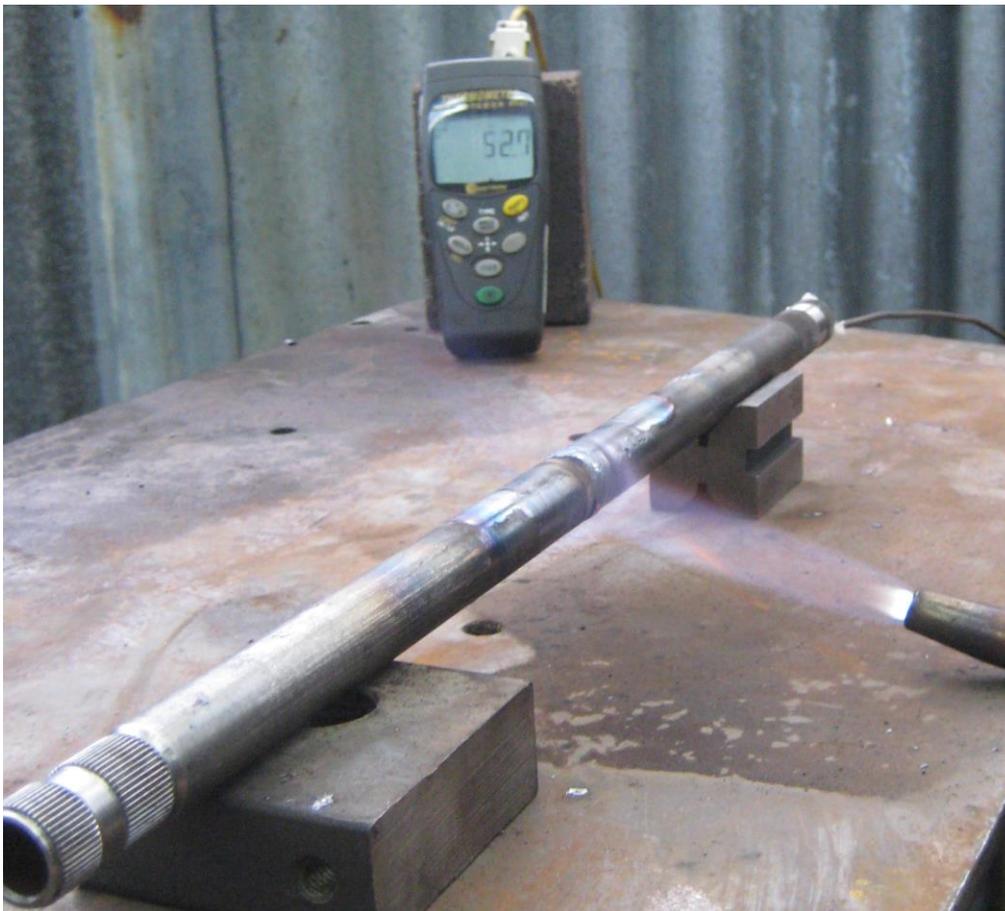
PWHT in progress, with thermocouple inserted in centre of spigot.

After welding the assembly was allowed to cool before being re-heated to a Post-Weld Heat-Treatment (PWHT) temperature of 550 degrees Centigrade and held for 20 minutes.

NOTE that thorough PREHEAT is required to avoid sub-surface brittle martensite cracks in material with a carbon equivalent of 0.3 or greater, and that PWHT is essential to do the following 3 things:

1. Change hard brittle martensite to tough tempered martensite
2. Reduce any high hardness to a more acceptable lower hardness
3. Relieve the massive contraction stresses created as weld-metal cools
