## 250SL Shifter Bushing Replacement

1. This information is regarding the bushings to the shift rod that directly connects to the transmission.

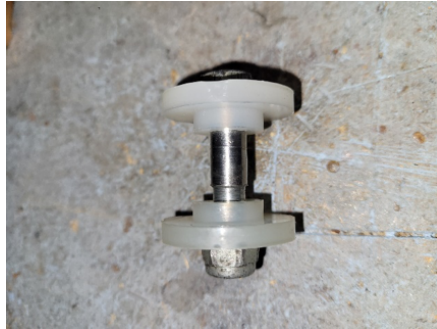
5. This is what the bushings look like before installation.

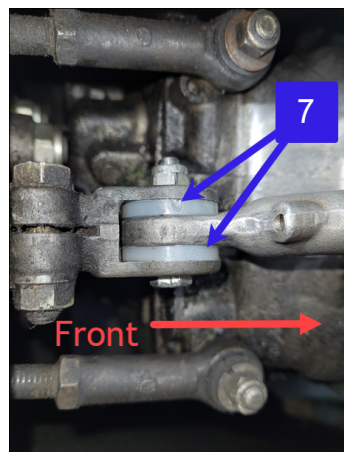
7. This image shows the new bushings installed.
