Clean the cooling system

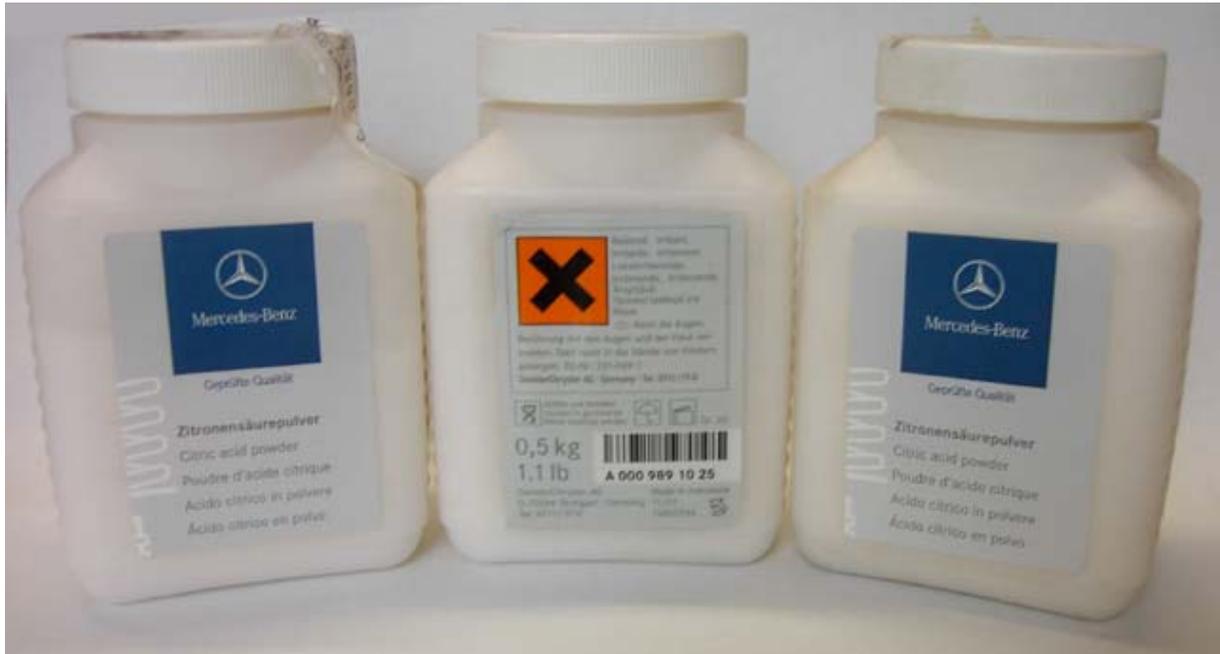
3x A0009891025 (je 0,5 kg citric acid powder) – much cheaper in wine cellars markets

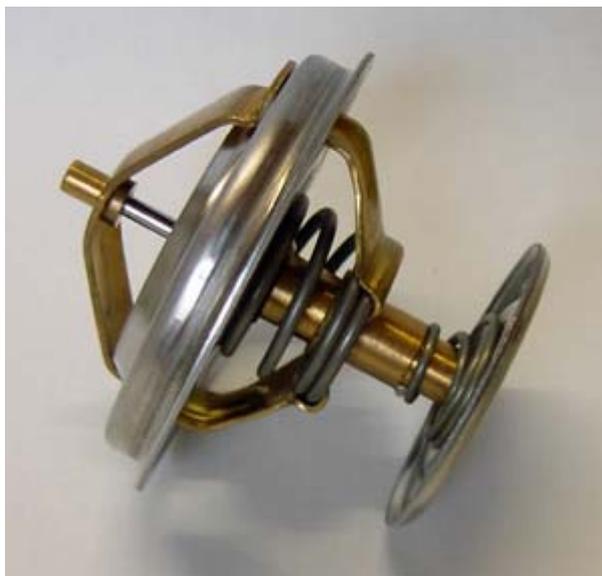
W000589746300 (forced openend thermostat) – not necessary, just remove the original thermostat

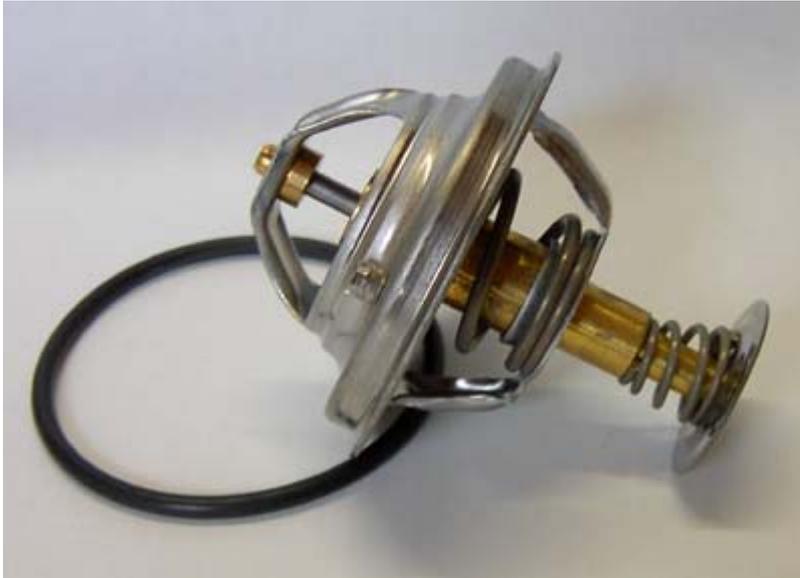
A1162000315 (new thermostat with seal ring, not necessary)

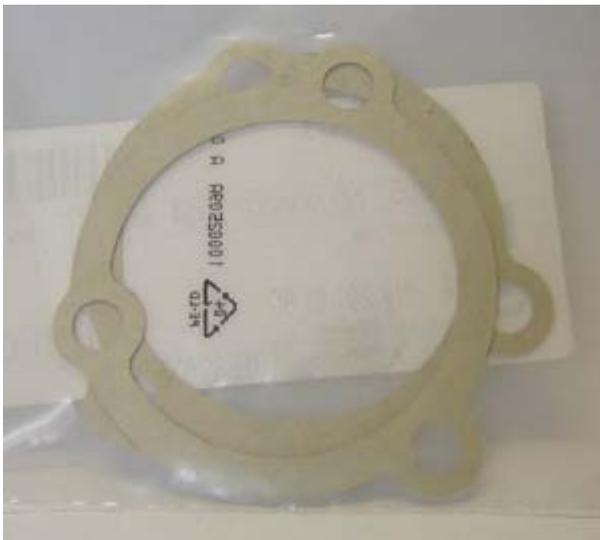
A1192010180 (new gaskets for water pump – not necessary)

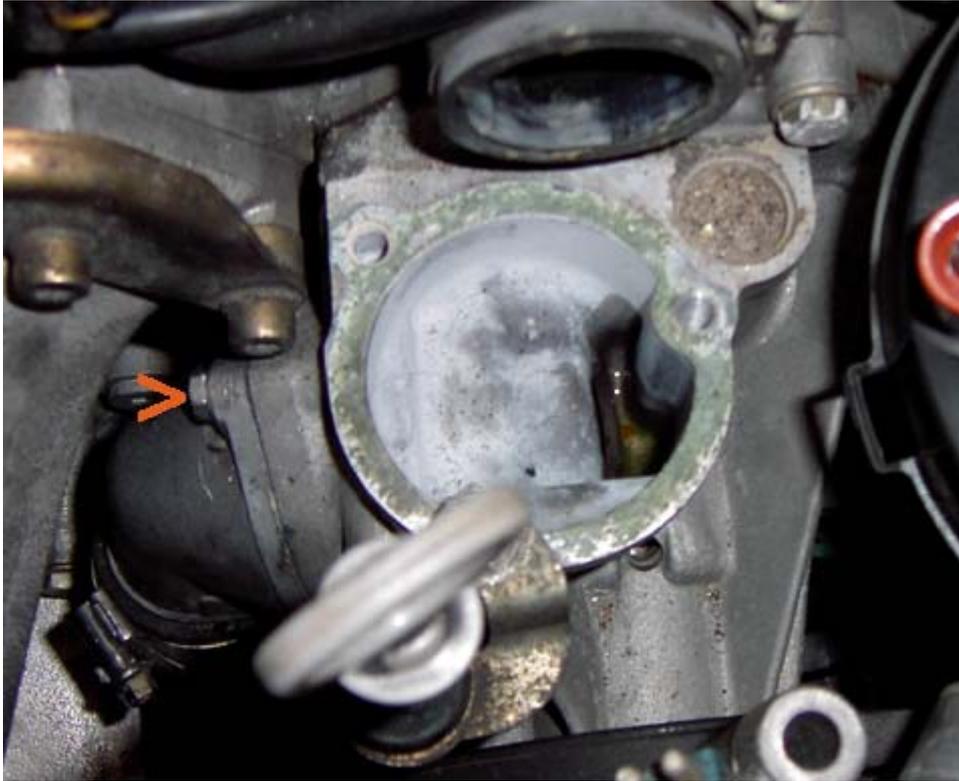
the top lid, where the official flush adapter would be connected, but to the side of it (the arrow marks the top of three screws):

Now it gets sneaky: the upper screw can be moved only with a spanner, but only has a range of motion of just 1/6 turn. The front screw, here covered by the handle of the dipstick, can be solved with a small ratchet without extension. It gets really bad with the rear screw. You can not get there with your fingers. It took me a while to discover I could get over the oil filter by putting together all the 1/4-inch extensions I could find:

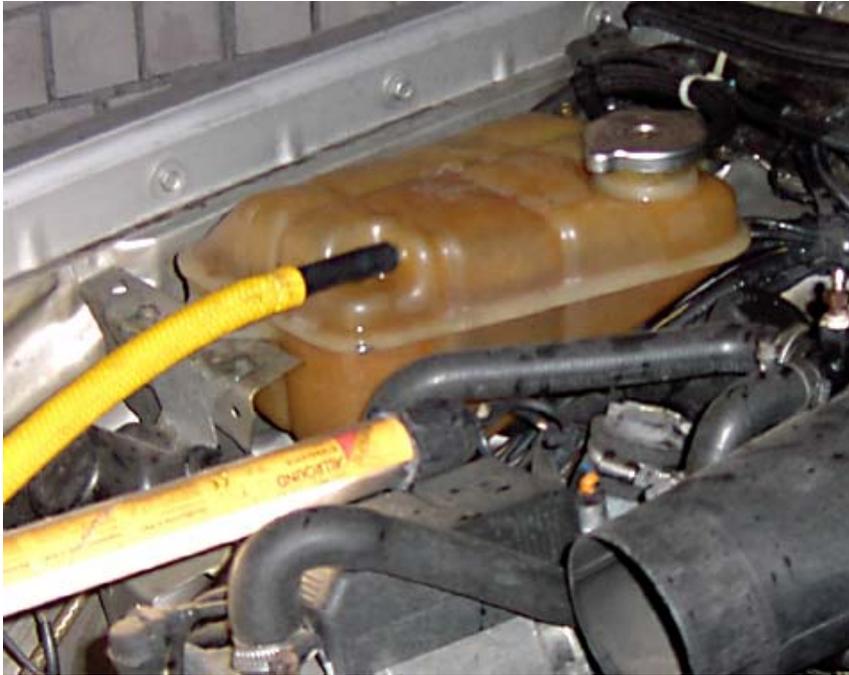
Once everything has been reassembled, the cooling system is filled with tap water and vented as usual. Since I could not get the rinsing adapter, as mentioned above, I came up with another solution. The upper hose from the radiator to the expansion tank I used as a drain. The free end was inserted into a thicker hose, so that the water could be specifically discharged. On the free connection to the

expansion tank I put a piece of thin hose on which I could put the garden hose. The lid must now be on it, so that the fresh water can not overflow through the filling opening. In the replacement solution, the fresh water is indeed fed elsewhere in the cycle, but on the way to the process, there is still ample opportunity to mix with the old cooling water, so that in principle the same effect is achieved as when using the rinsing/flushing adapter,

Now follows the first rinse (according to the instructions, the engine is running at about 2500 1 / min) to remove the remains of antifreeze. After about 5 min. only clear water comes out. Now the water is drained from the cooler again and filled in 5 liters of tap water dissolved citric acid powder. The small hose can now be reconnected to the expansion tank. After the obligatory bleeding (bringing the fill level to the target level with tap water), the engine should be left for approx. 15 min. with increased speed (2500 1 / min) run. The cooling water reached about 82 °, and you could hear occasionally, as the viscous fan switched to full power. After the flushing time, the now dirty water is drained off. After that takes place for 10 min. Another flushing process (as usual fill with water and bleed), the engine should run again at about 2500 1 / min. You can observe how the escaping water slowly becomes clearer. I occasionally caught the running water in a white bowl and could see as well as it was brownish in color and became clearer over time.
